# New irrigation solutions for Spotswood farming community

## **Project Description:**

To provide a community and on-farm irrigation system that resulted in an economic, practical and easy-to-operate scheme.

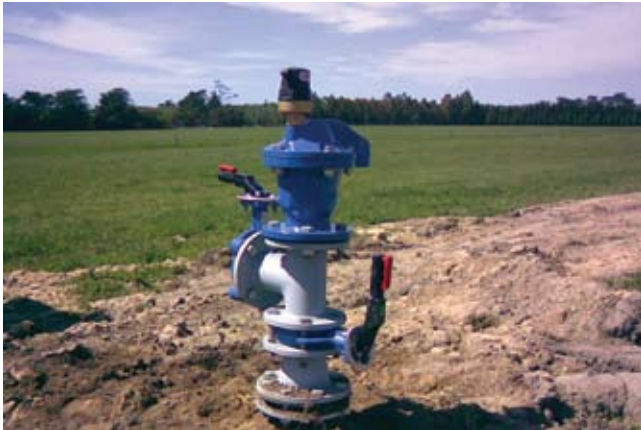
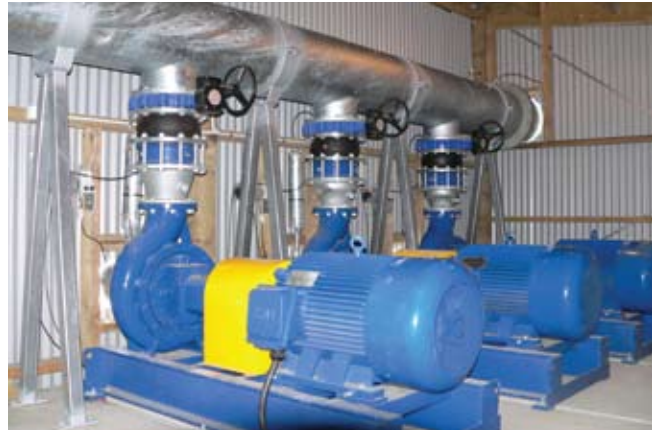
# Phoebe Irrigation System

Some of the features of this system design are:

- Automatic priming system to ensure positive prime at all times.
- With pumps being the same, servicing, replacement and even the option of having a spare pump available is very beneficial.
- Two of the pumps are driven by a Variable Speed Drive (VSD), two being on soft start. This ensures full automation (and redundancy should one of the VSDs fail).
- Dialling system, so should there be a fault then the operators will be advised by text messaging.
- The mainline to the two booster pump shed locations is 630mm Marley medium density pipe with a 6 bar pressure rating. The pipeline was delivered in 12m lengths and joints welded onsite.

Water for irrigation was to be drawn from a bed-mounted gallery in the Waiau river. This would connect into a manifold with four 350mm steel pipe risers from which are connected the suction pipes to four end suction centrifugal pumps. Currently only three pumps are installed.

The four pumps are identical, being Goulds 250 x 200-400 pumps running at 1400rpm, delivering 137lps at 40m head and pumps powered with 90kw motors. Typical of the conservative design approach is the fact that if there is a pump failure, three pumps can nearly achieve the full duty.
